Manhole Inspection Summary

Manhole # S37KK_012MH

Insp Date: **3/20/07 10:44 AM**

Location Address: **1904 GREENMOUNT AVE**

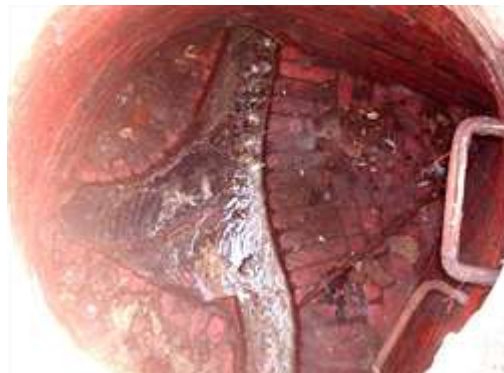
Top View

Corroded steps. Evidence of surcharge - Bench debris. Channel debris.

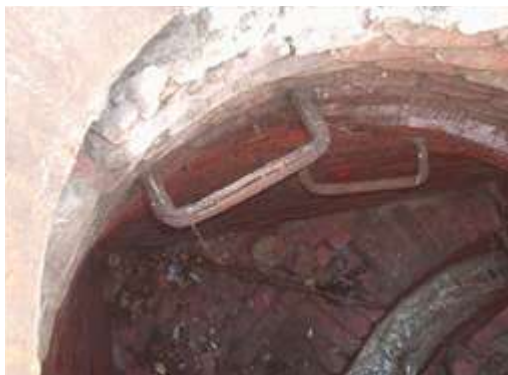
Defect

Frame leaks. Adjustment deterioration and infiltration. Corbel and Barrel infiltration.

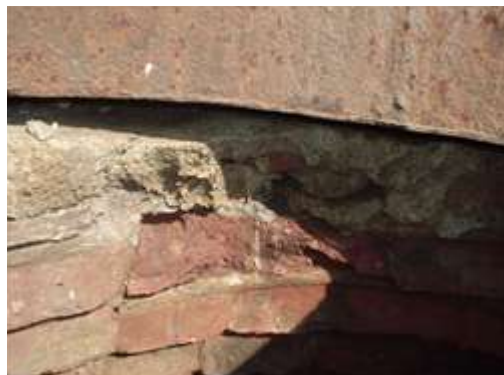
Defect

Frame leaks. Adjustment deterioration and infiltration.

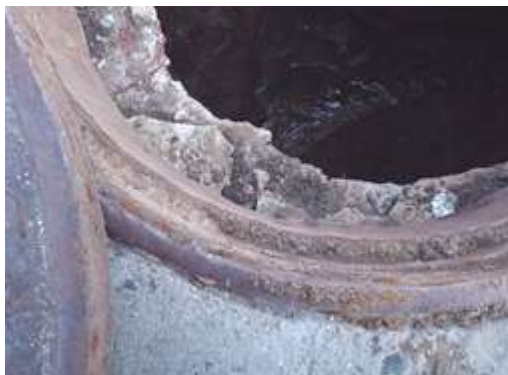
Defect

Frame leaks. Frame offset. Adjustment deterioration, loose brick and infiltration.

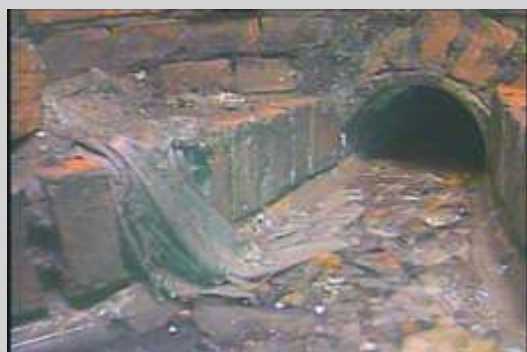
Pipe Out @ 12 O'Clock

Channel deterioration.

Deposits: ☐ None ☒ **Mud** ☐ Sludge ☒ **Debris** ☐ Grease

Infiltration: **None** Pipe Seal Cond: **Cracked**

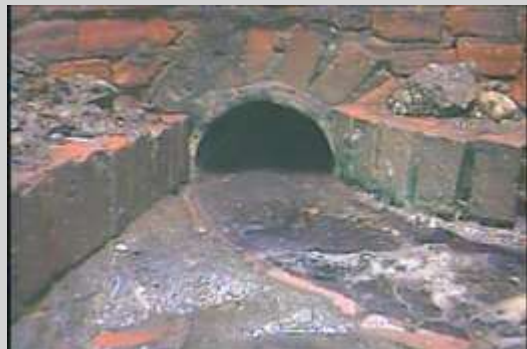
Pipe In @ 9 O'Clock

Deposits: ☐ None ☒ **Mud** ☐ Sludge ☒ **Debris** ☒ **Grease**

Silt Depth: **2** (in.)
